# N617CC

## 1980 Cessna 421C

# FAA Form 337's

**Aircraft S/N: 421C-0897**

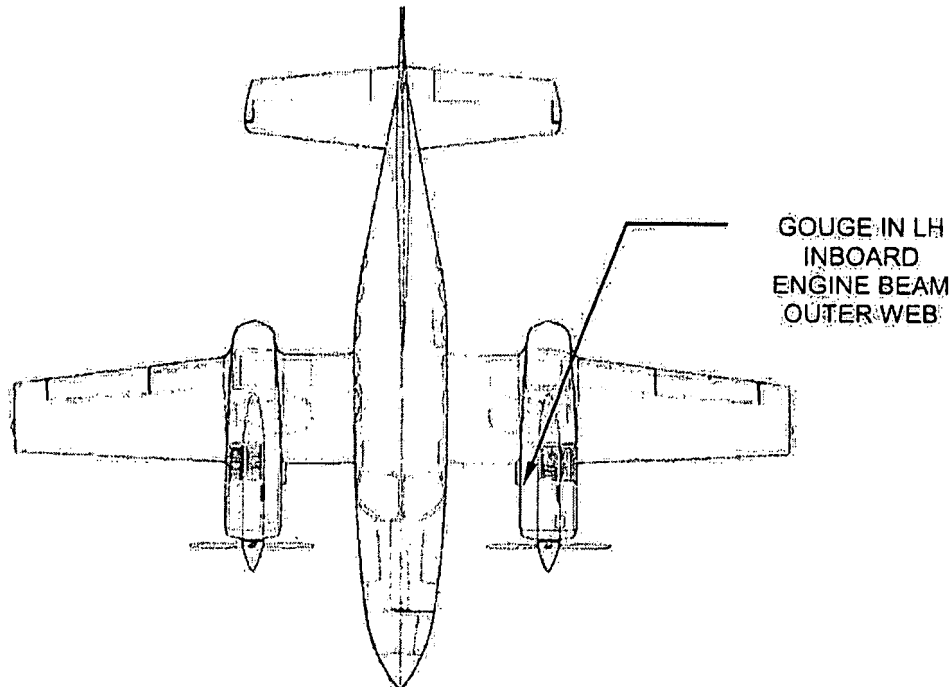
FIGURE 2.1:  
GENERAL AIRCRAFT DAMAGE LOCATION

Chafe damage was found in the LH Inboard Engine Beam -- Outer Web at FS 115.00.

Figure 2.1 is a sketch showing the general location of the damage. Figure 2.2 are actual photographs showing the damage to the LH engine beam.

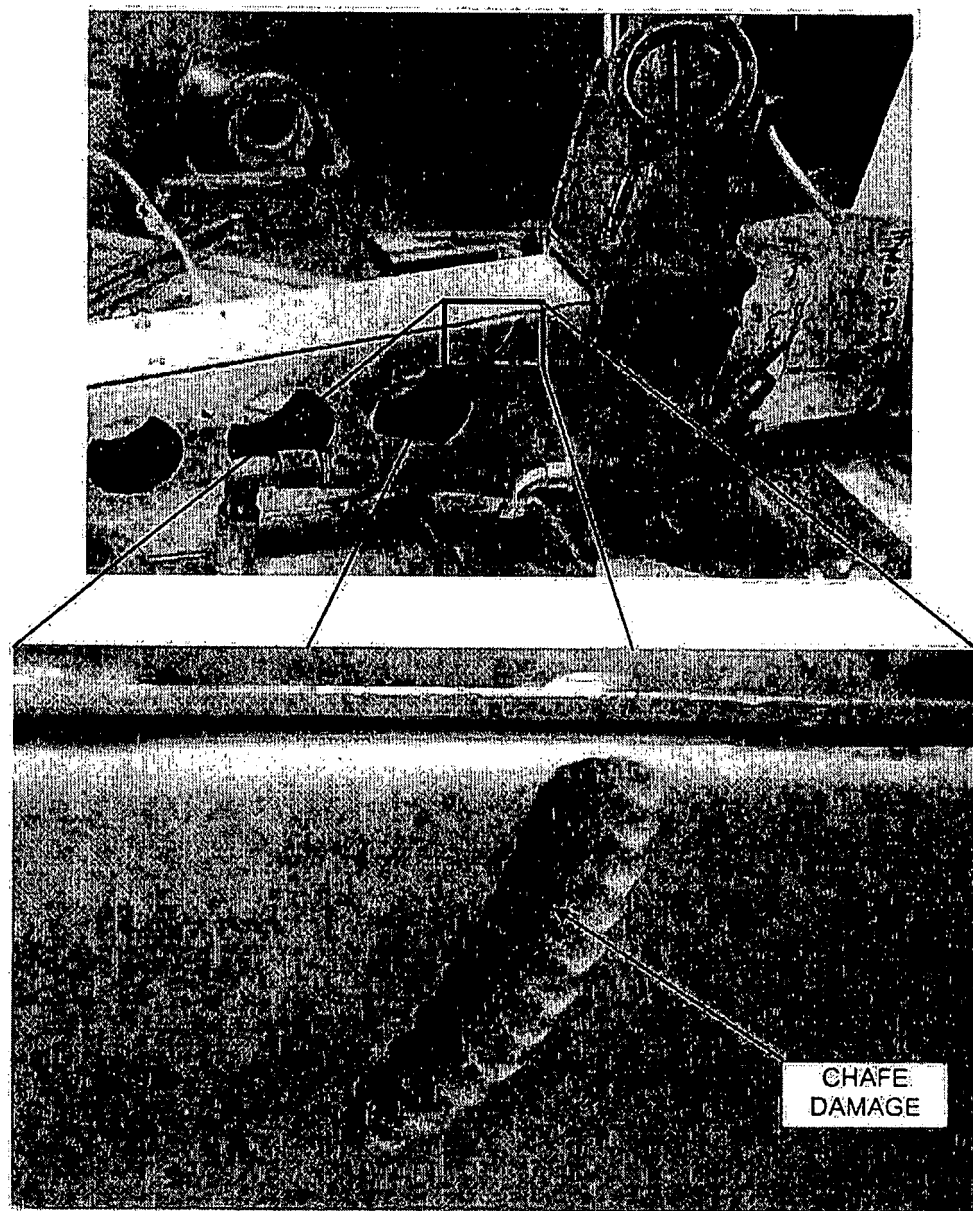
FIGURE 2.2:  
DAMAGE PHOTO - LH INBOARD ENGINE BEAM

Eddy current inspection performed by Certified Inspection Services FAA Repair Station X18R997N, no cracks noted.

(VIEW LOOKING INBOARD/DOWN AT INNER LH ENGINE BEAM @ FS 115.00)

Repaired chafe damage per Cessna Aircraft Company Repair definition S-421C-0897/01RD, Cessna 421C Maintenance Manual, Supplemental Inspection Documents SID 54-10-04 and SID 53-10-04, and AC43.13 1B.

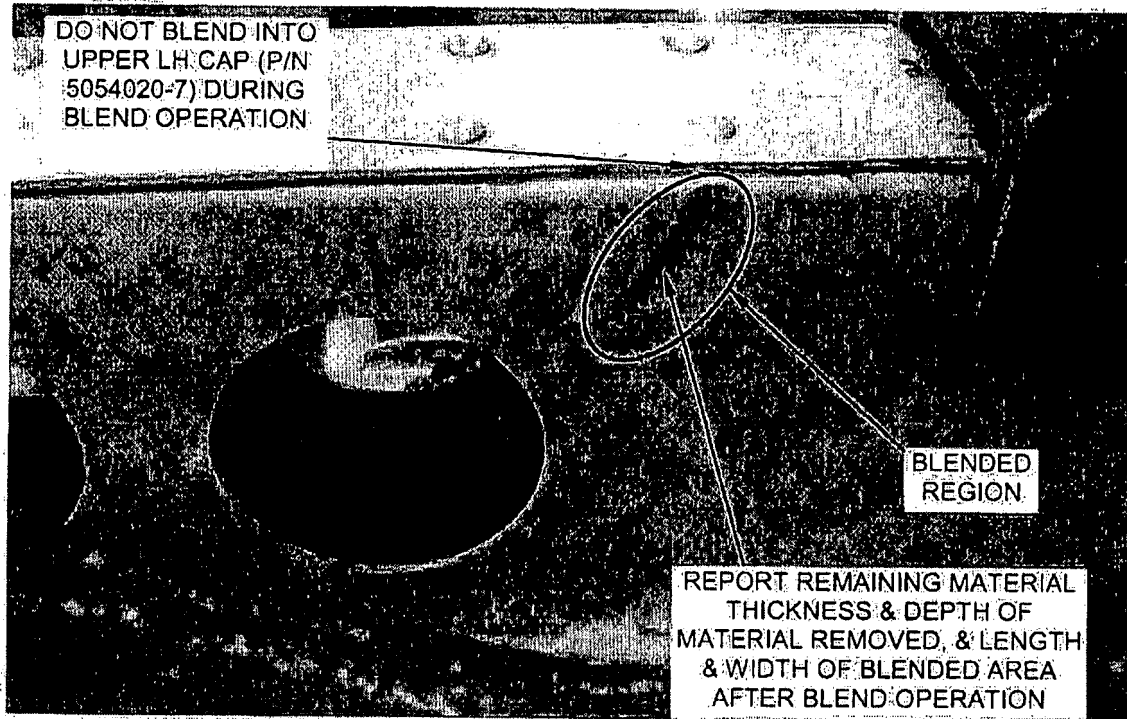
FIGURE 3.1  
REPAIR DETAIL - LH ENGINE BEAM BLEND

(VIEW LOOKING INBOARD/DOWN AT INNER LH ENGINE BEAM)

- Break all edges to 0.03 to 0.06 inch radius, clean, chem. film and epoxy prime all bare aluminum surfaces and abrasive clean and epoxy prime all stainless steel surfaces per the applicable Model 421C Service Documentation.

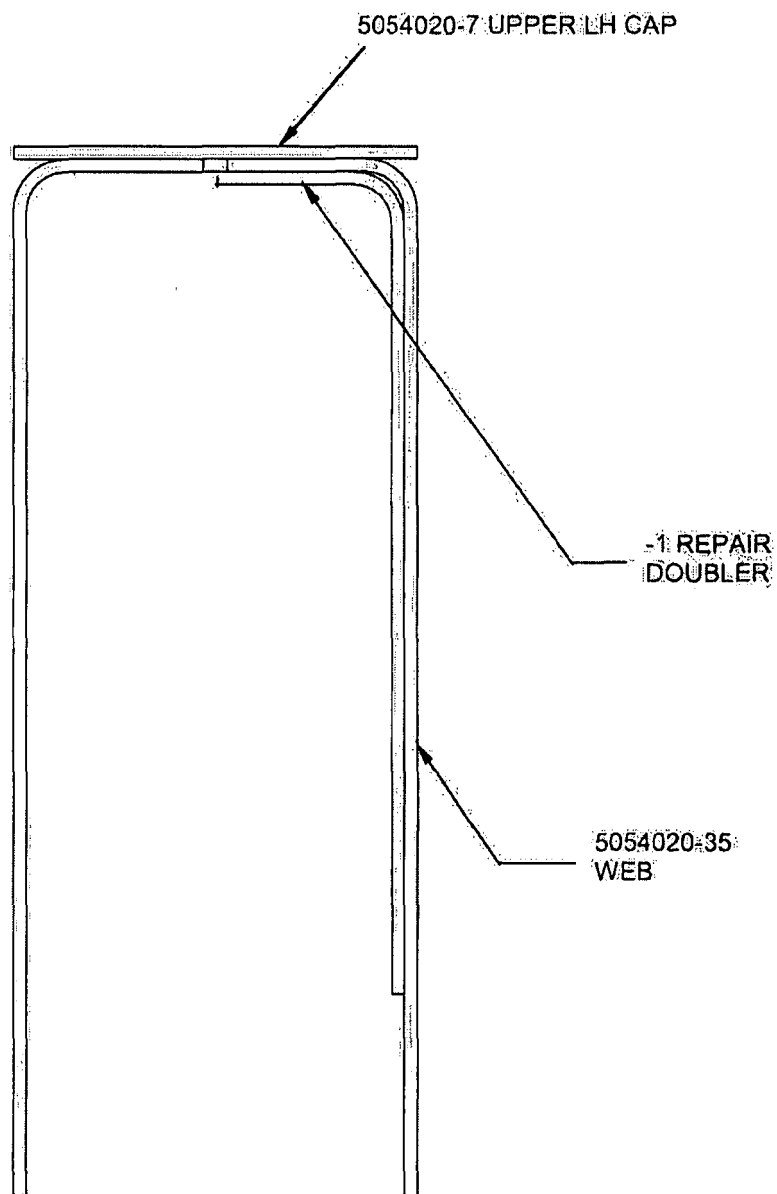
FIGURE 3.4  
REPAIR SKETCH

SECTION B-B  
VIEW LOOKING AFT

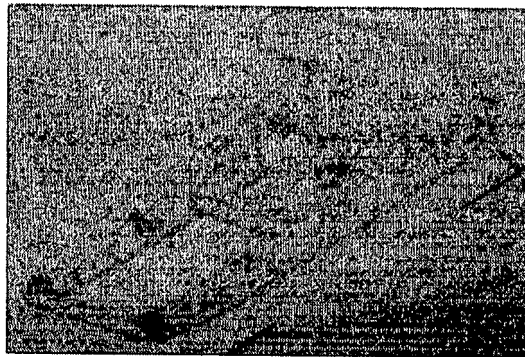
Perform a ultrasonic thickness inspection on the left nacelle –inboard beam in the area of chaffing, readings were taken in .025" increments fwd and aft of the blended area and, at the top and bottom of area. Thickness reading taken from the backside of the center area the average thickness is approx. .050".

FDW	Center	Aft	Top	Bottom
.052	.047	.050	.053	.053
.050	.045	.052
