# N53RD

## 1981 Cessna Citation I

# Damage History Entries

REPAIR OF DAMAGE ON THE LOWER RH WING SKIN

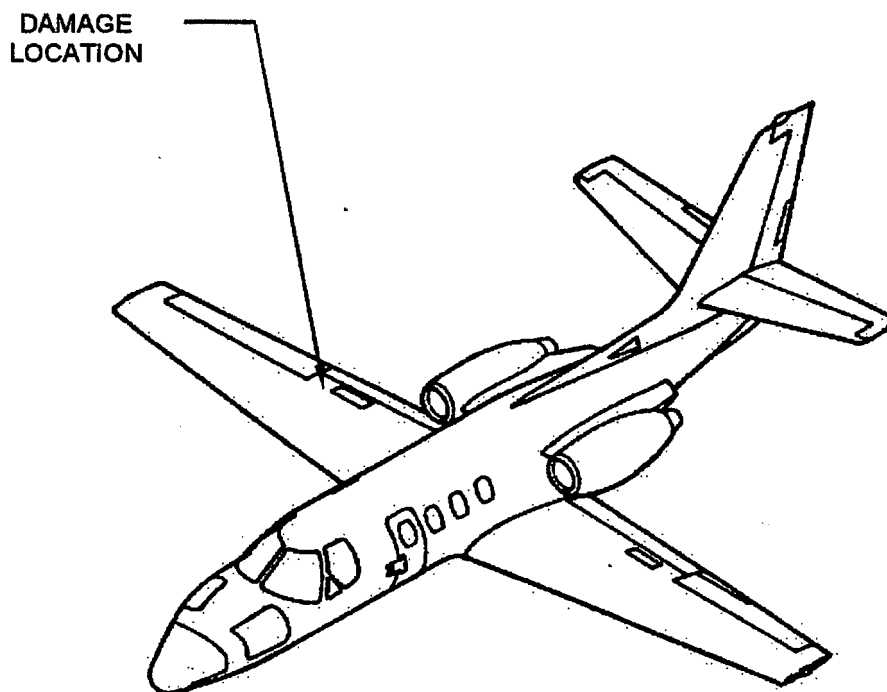
FIGURE 2.1:  
GENERAL AIRCRAFT DAMAGE LOCATION

The RH wing SKIN (P/N 5522551-6) was punctured outboard of WS91, the puncture was between the aft spar and the stringer immediately forward. The puncture was approximately 4 inches in diameter. There was also damage to the Rib Cap (P/N5522620-50).

Figure 2.1 is a sketch showing the general location of the damage. Figure 2.2 is a photograph of the damage provided by the repair facility.

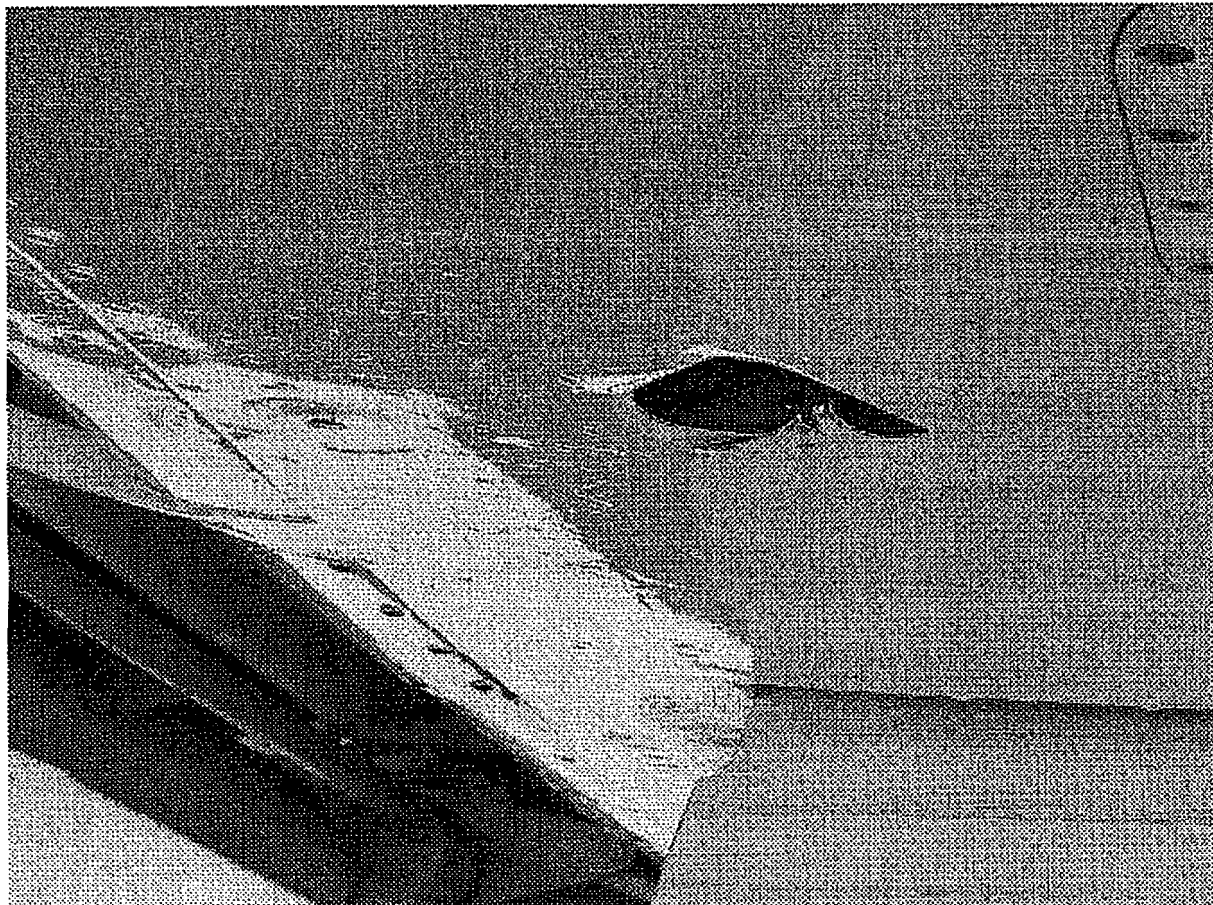
FIGURE 2.2:  
DAMAGE PHOTOGRAPH

(VIEW LOOKING INBOARD AT DAMAGE IN THE LOWER RH WING SKIN (P/N 5522551-6))
