# N617CC

## 1980 Cessna 421C

# FAA Form 337's

**Aircraft S/N: 421C-0897**

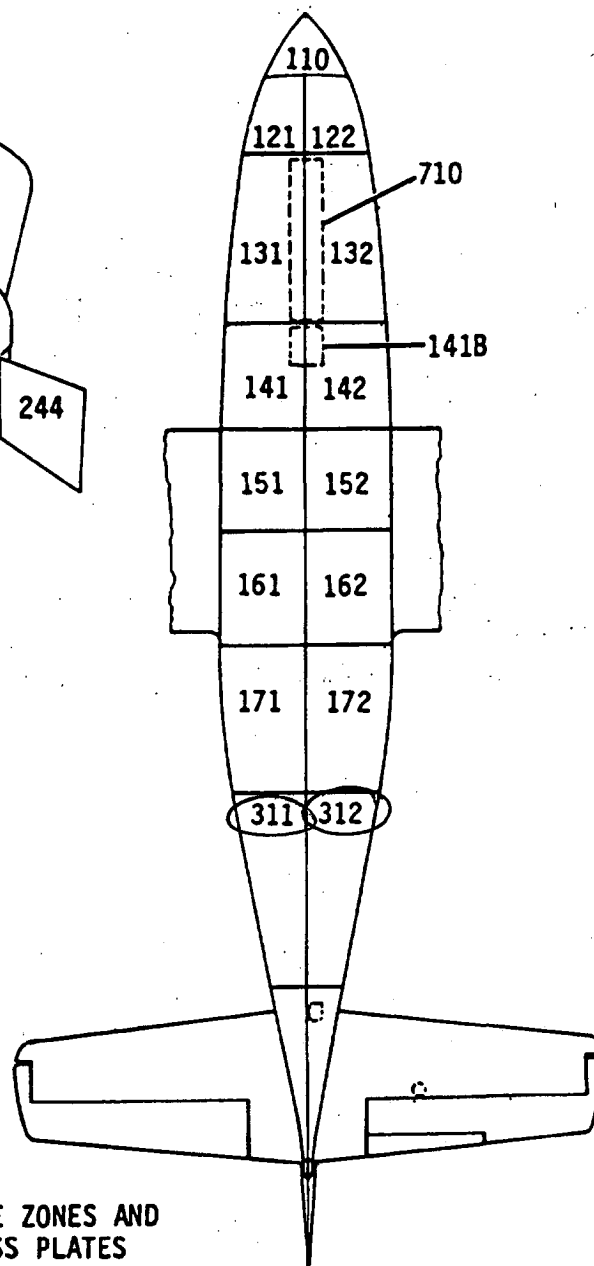
Ref. 1

REPAIRED CRACK IN SKIN @ ZONE 311 AND 312 (REF. 1). ON BOTTOM OF FUSELAGE AFT OF PRESSURE VESSEL AT LOCATION OF FLIGHT PHONE ANTENNA MOUNT (REF. 2).  
AS PER CESSNA 421 SERVICE MANUAL (1976-1985) REV. 23,  
CHAP. 15 STRUTURAL REPAIR,  
SECTION 40,  
PAGE 16,  
FIGURE 13,  
SHEET 1 (REF. 3)  
DIMENTION OF PATCH 1ea. 8 5/8" X 5 5/8" X .025 2024 T3 alclad AND 1ea. 4 5/8" X 3 3/4" X .025 2024 T3 alclad  
DIMENTION OF DOUBLER 1ea. 12" X 13 1/2" X .025 2024 T3 alclad  
RIVETED PATCH AND DOUBLER AS PER CHAPTER 15,  
SECTION 00,  
PAGES 1-14
